## Myersville Survey District

### **Architectural Survey File**

Property/District Name: Myersville Survey District \_\_\_\_\_ Survey Number: F-4-53

# Maryland Historical Trust State Historic Sites Inventory Form

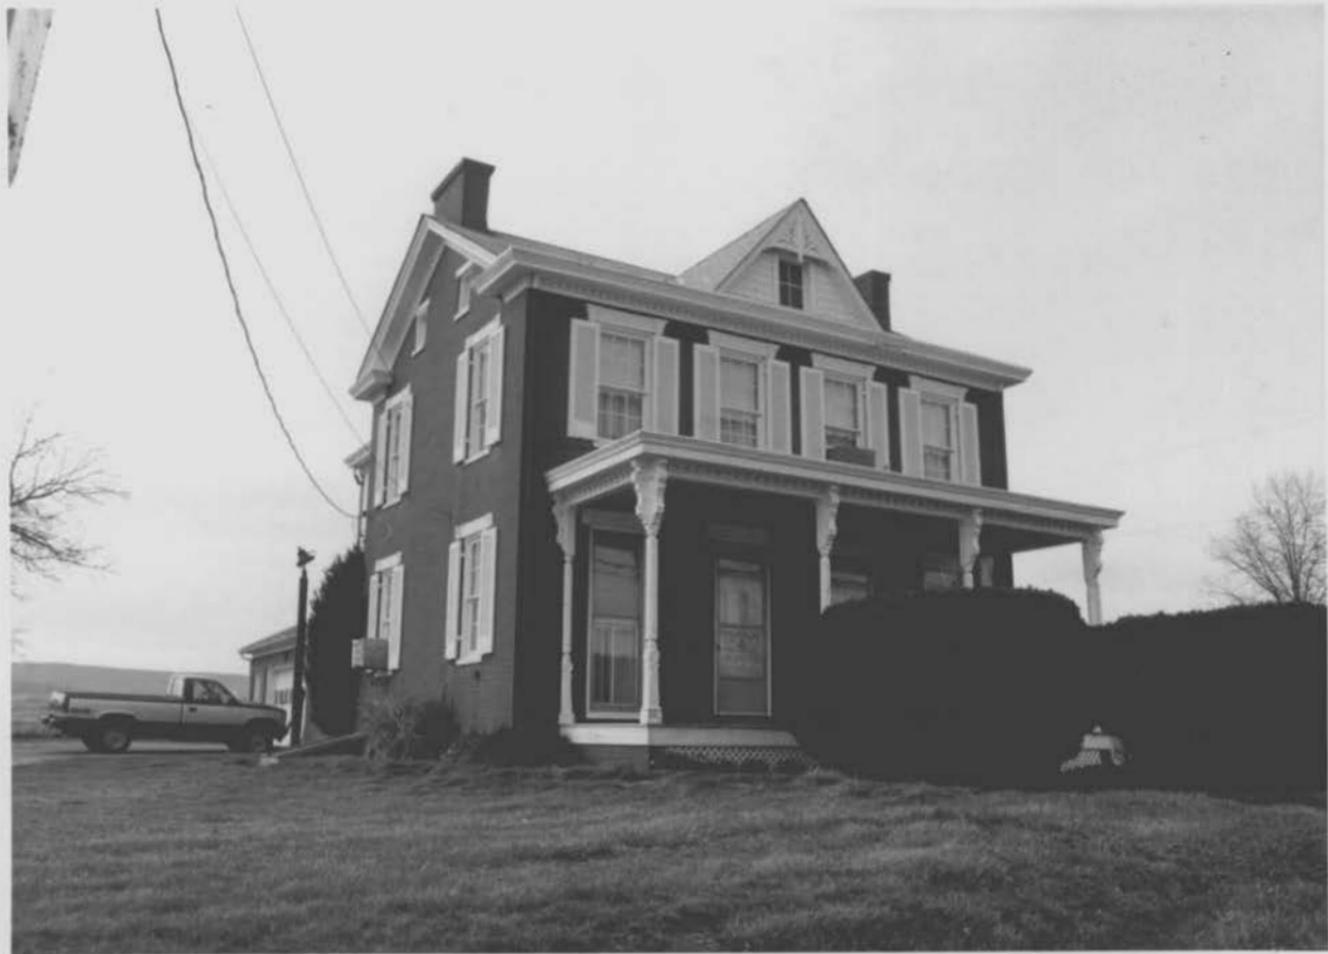
2/27

Smith House, 100 Main St.: The house is a two-story, four-bay brick dwelling with a central cross gable covered with shingles and ornamented by scroll-sawn gable trim. A one-story porch with brackets shelters the east elevation first story. A two-story rear wing extends from the northwest corner and modern additions have extended the wing to the south wall line of the main section. The window openings have molded lintels with louvered shutters. There are two entrances with transoms in the first story east elevation. The property also contains a small frame barn. Located at the southern end of the survey district, it is surrounded by open land. About ten feet north of the house stood the first structure erected in the Myersville vicinity, a log house built by James Stottlemeyer in 1742, according to Moser's 1905 History of Myersville.

Smith House - 100 Main St., East Crownsville

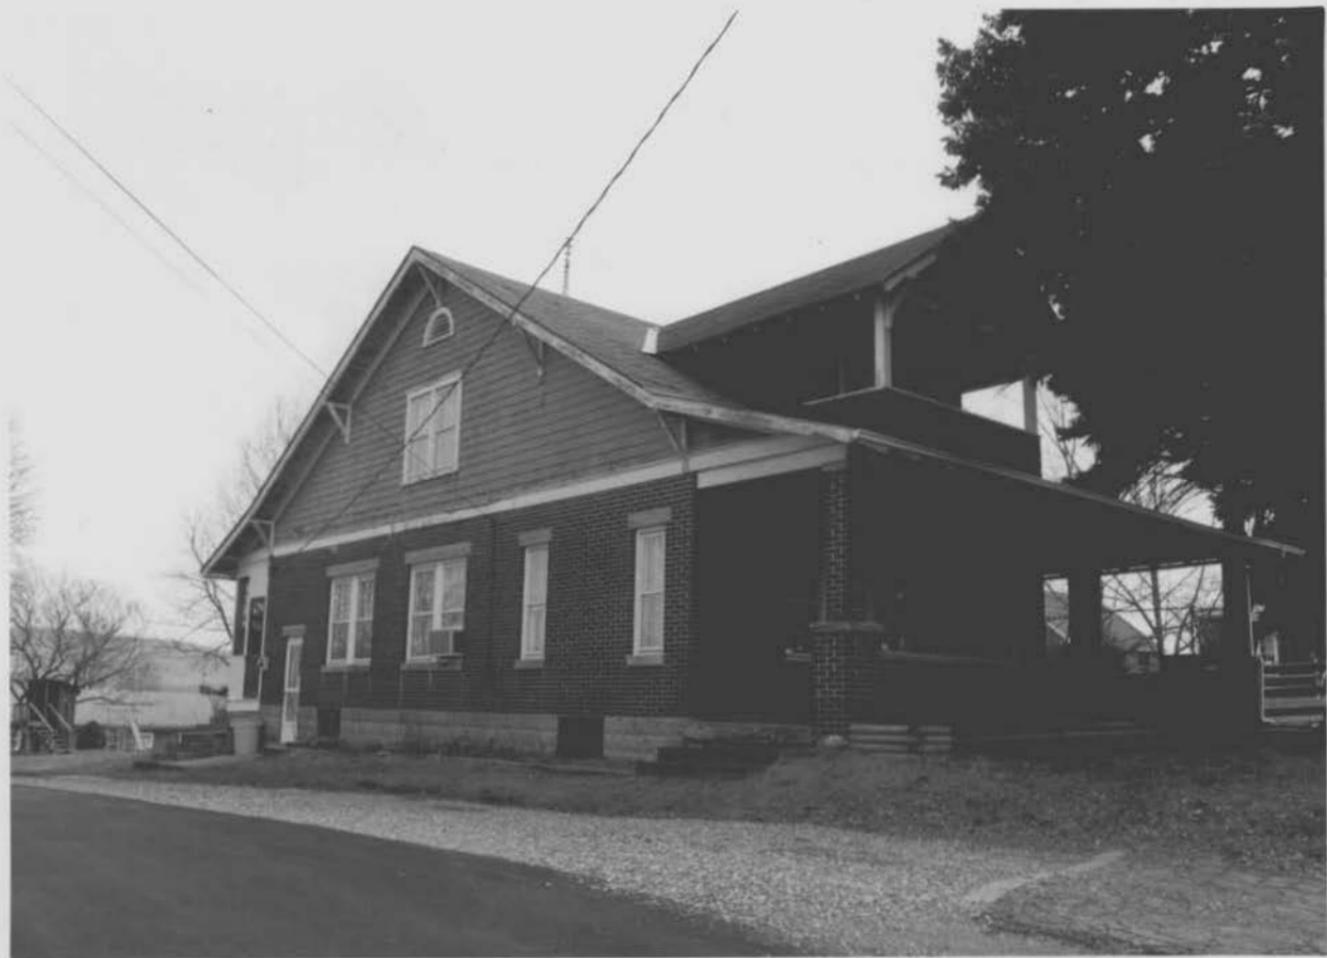
2/23

103 Main St.: This is a circa 1928 bungalow with 1-1/2 stories, with a brick covered first story and a wood shingled upper story, extended eaves and wood brackets. The gable roof is covered with composition material and has an inset dormer with a sleeping porch above the first story porch supported on brick piers. The foundation is rusticated concrete block and the windows have rusticated stone lintels and sills. The sash is 3/1. The design is very similar to a Sears, Roebuck Catalog house, the Bedford, which appeared in the 1926, 1928, 1929, and 1933 catalogs. The house was probably built by Lloyd R. Brandenburg.

103 Main St., north west corner view

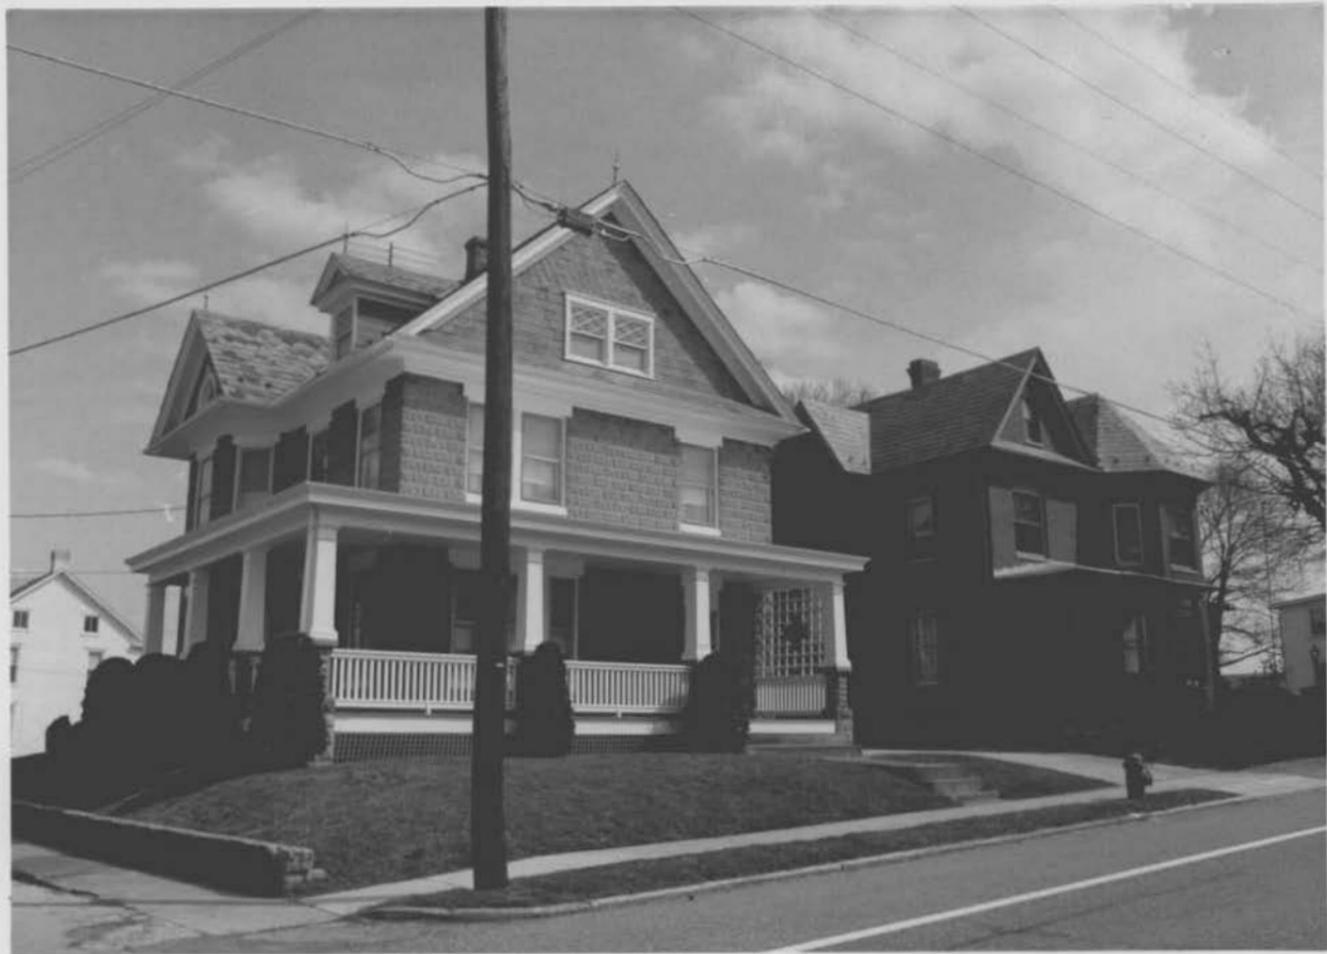
4/23

Hildebrand House, 109 Main St.: Built about 1905, the brick Colonial Revival house has 2-1/2 stories and an irregular plan with projecting gabled sections on the west and south elevations. Two porches, one with Ionic columns, flank a corner polygonal bay at the southwest corner. The roof is slate and the window openings have segmental arches. Built by John T. Hildebrand, a carriage maker, it is one of several large residences built after the Myersville and Catoctin Electric Railway was constructed in 1898.

111 Main St.: This is a 2-1/2 story rusticated concrete block dwelling in the Colonial Revival style built about 1913, possibly by John T. Hildebrand. It has projecting gables and dormers covered with slate, a slate roof, and a wide veranda on the north and west elevations. The windows are 1/1 and have plain lintels. The molded cornice is very prominent. The use of concrete block for dwellings began in Frederick County about 1906; this is one of two houses in the survey district in this material.

109 - 111 Main St., Northwest Corner view

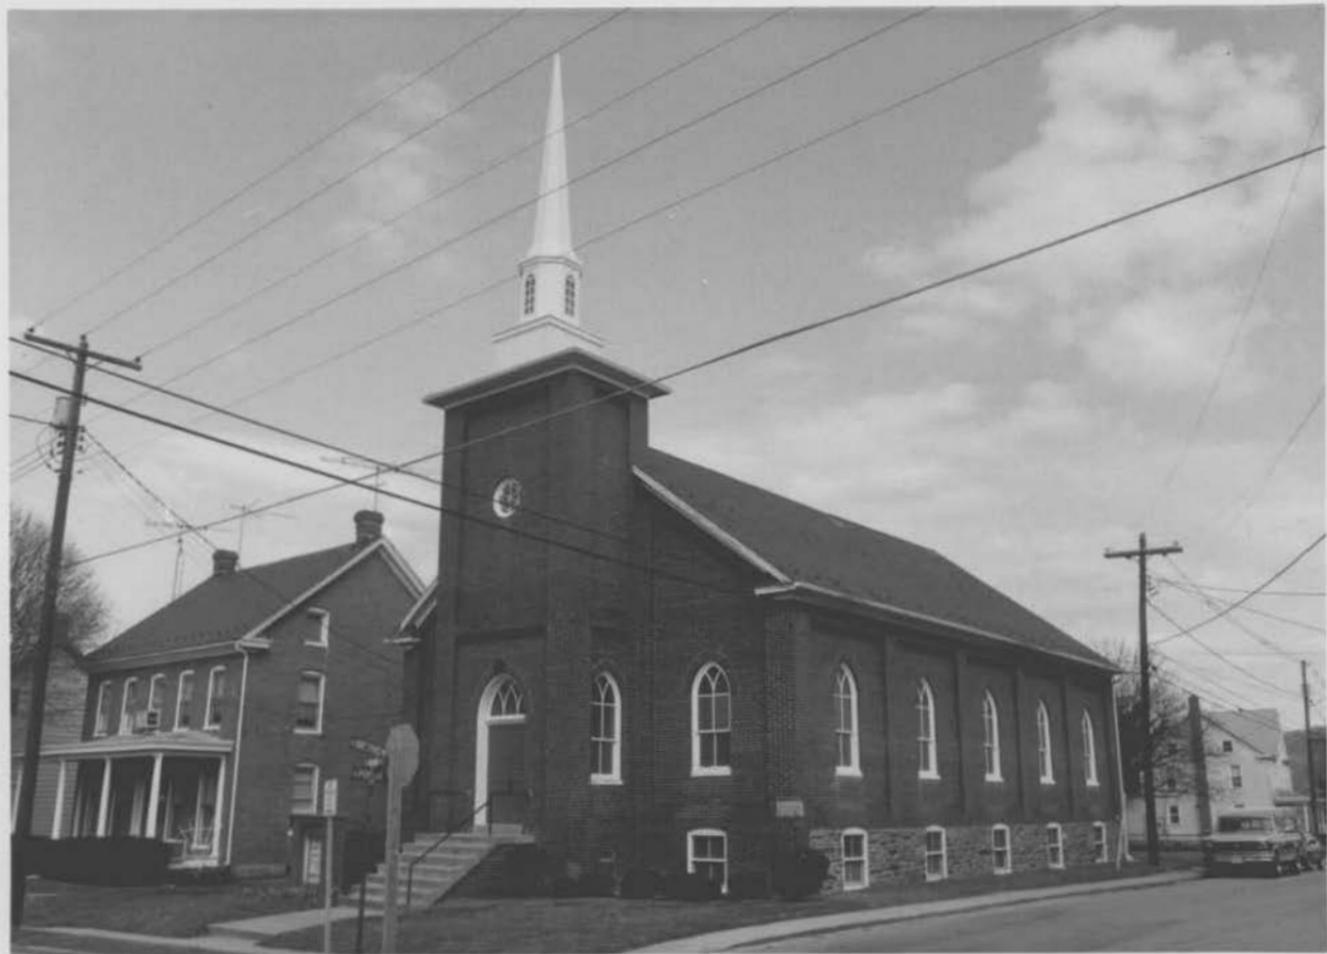
5/23

Myersville Church of the Brethren: Built in 1913, this one-story brick church has a raised stone foundation and a projecting tower on the west elevation containing the entrance. The side elevations have five bays with Gothic arched windows. The side bays are recessed with dog-tooth courses. The gable roof is patterned slate and the steeple appears to be a modern addition to the originally flat-topped tower. At the southwest corner is a granite stone inscribed "Schwarzenau" with the date 1913. Schwarzenau, Germany was the birthplace of the German Baptist Church and one of the founders of the Myersville congregation traveled to Germany to obtain this stone to be placed in the new building.

Ch. of the Brethren, Main St., southwest  
corner view

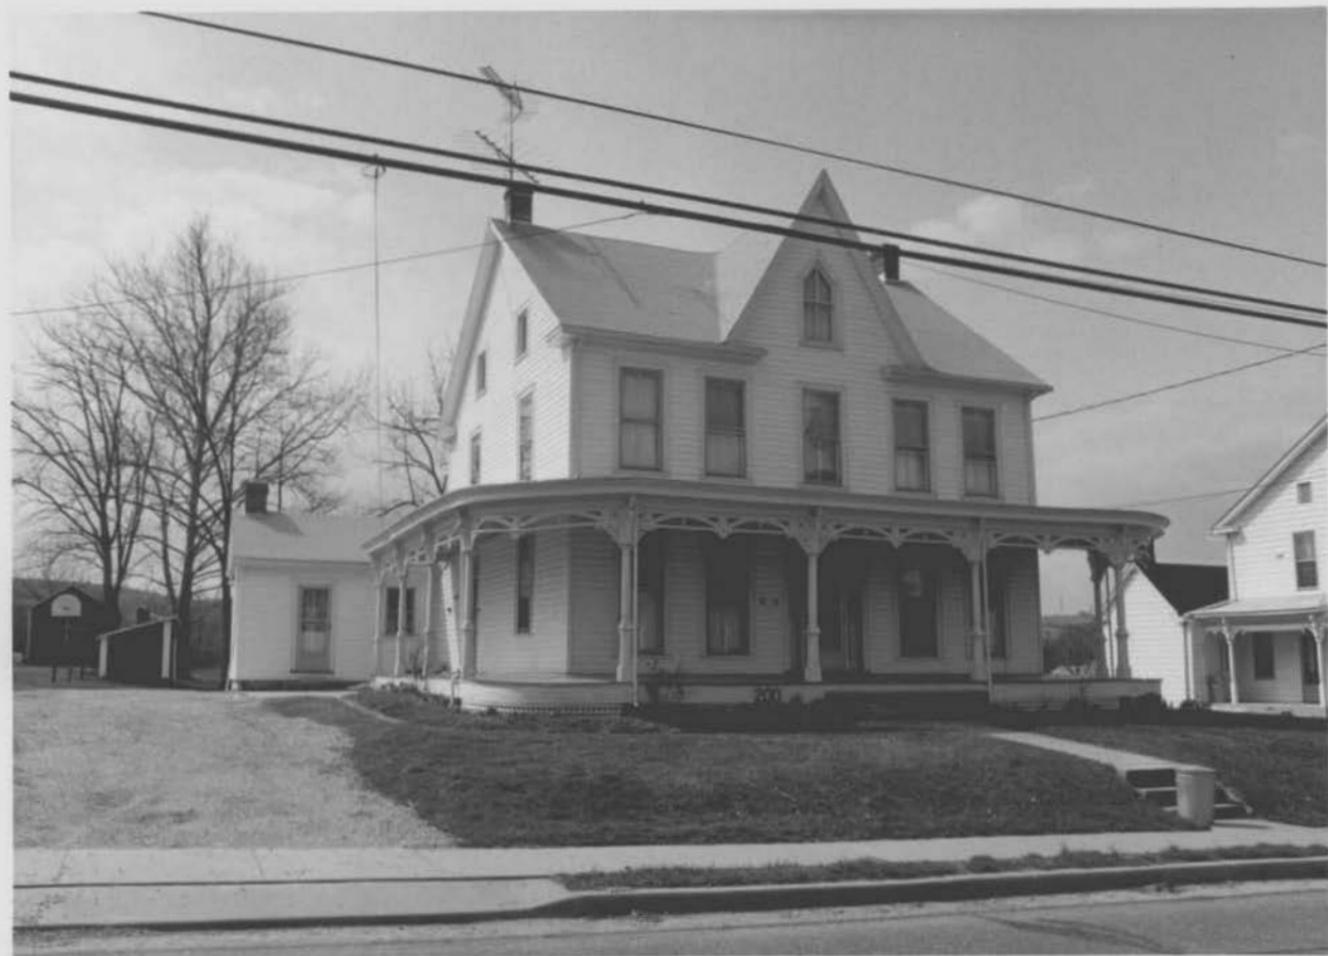
6/23

Shank House, 200 Main St.: The two-story frame dwelling built about 1882 has a five-bay east elevation with a center entrance and a one-story porch which wraps around three sides of the house. A cross gable with a pointed arch gable window with 2/2 sash dominates the east elevation. The vinyl siding probably covers rusticated wood siding as shown in a photo in Moser's 1905 History of Myersville. The porch has scroll-sawn trim and turned columns which are also seen in the 1905 view. The roof is composition. The sash is 2/2 in arched frames. The Shank House was a hotel and boarding house from at least the 1890's to the 1920's, when the interurban railway connections appealed to summer visitors from the nearby cities. The photo in the 1905 history indicates the rusticated siding was painted in alternating colors, giving a diagonal striped appearance to the exterior. The quoins were painted a darker color.

Shank Hotel, 200 Main St., east elevation

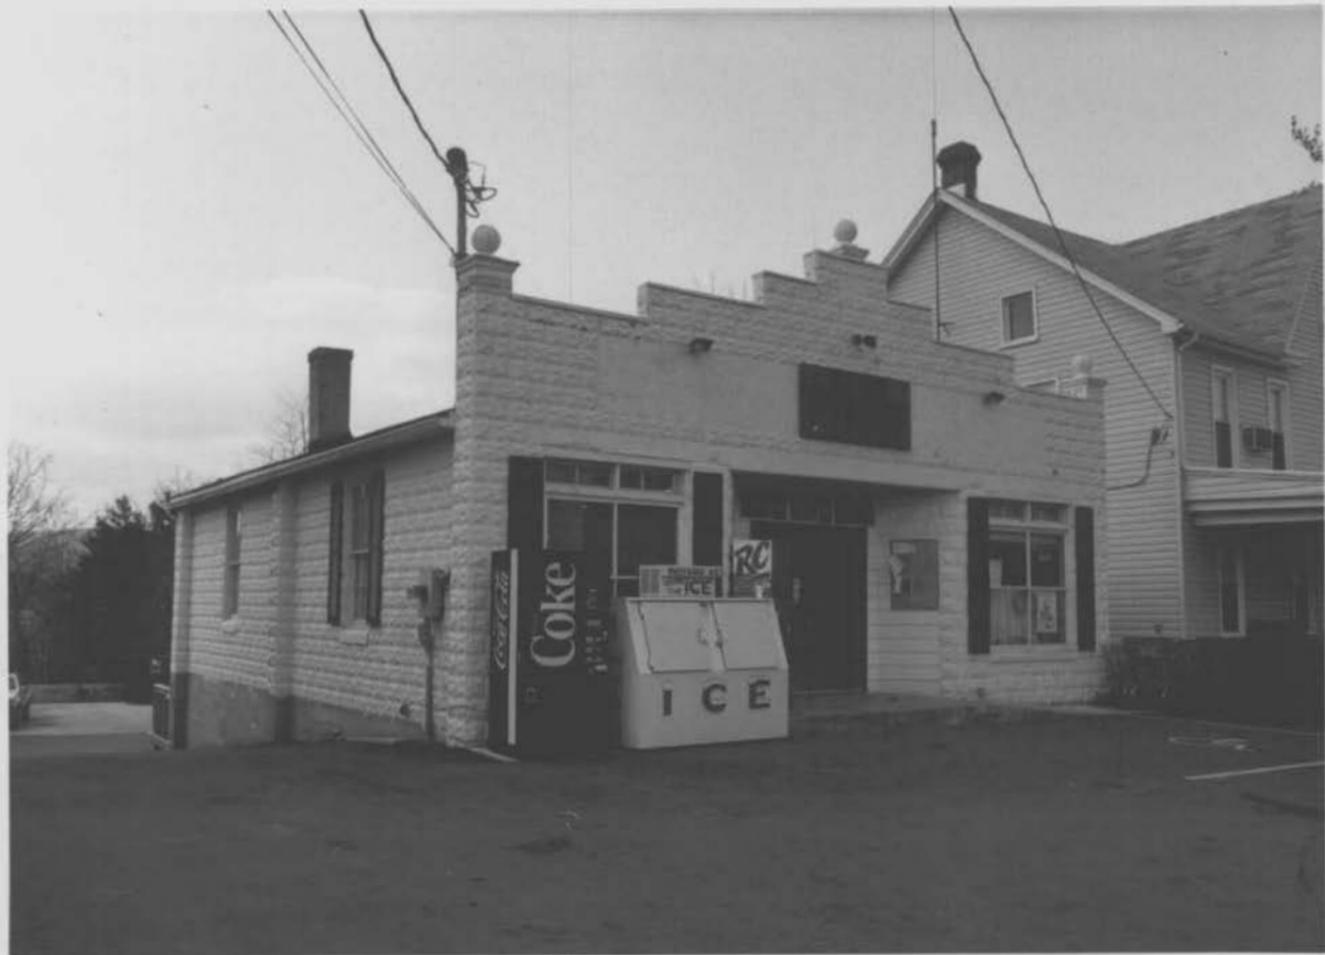
7/23

Myersville Motor Company, 308 Main St.: Now a convenience store, this one-story rusticated concrete block building was erected about 1916 as the town's first auto dealership and repair garage. The east elevation has a stepped parapet with globe finials and a three-bay facade with a recessed center entrance. The door is a modern replacement and the flanking windows have 2/2 sash. The Myersville Motor Company sold Hudson, Dodge, Essex, and Willys Overland cars.

Myersville Motor Co., 308 Main St., east elevation

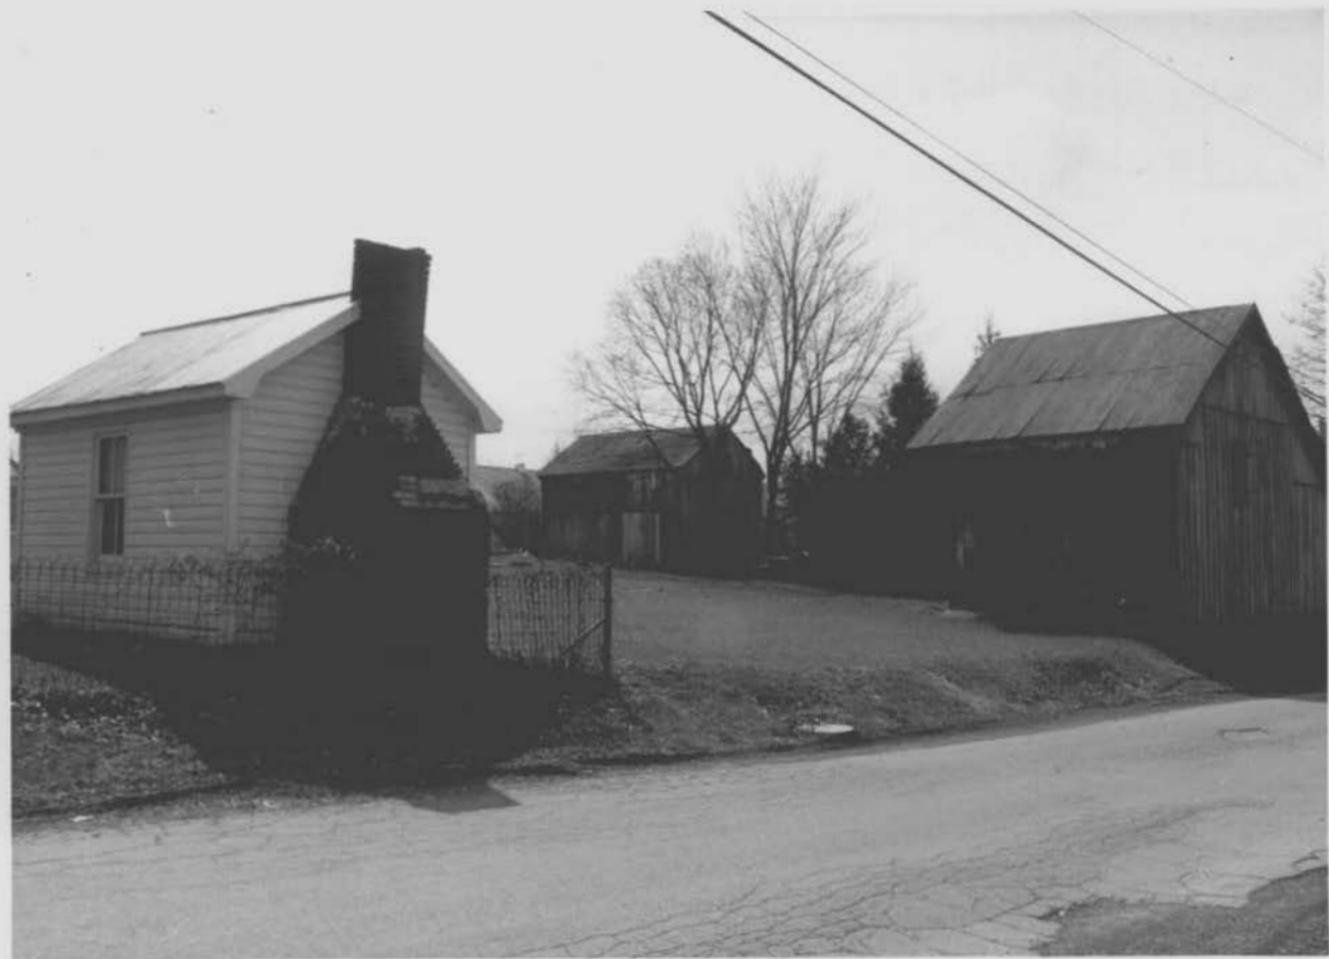
8/23

Northeast corner view.

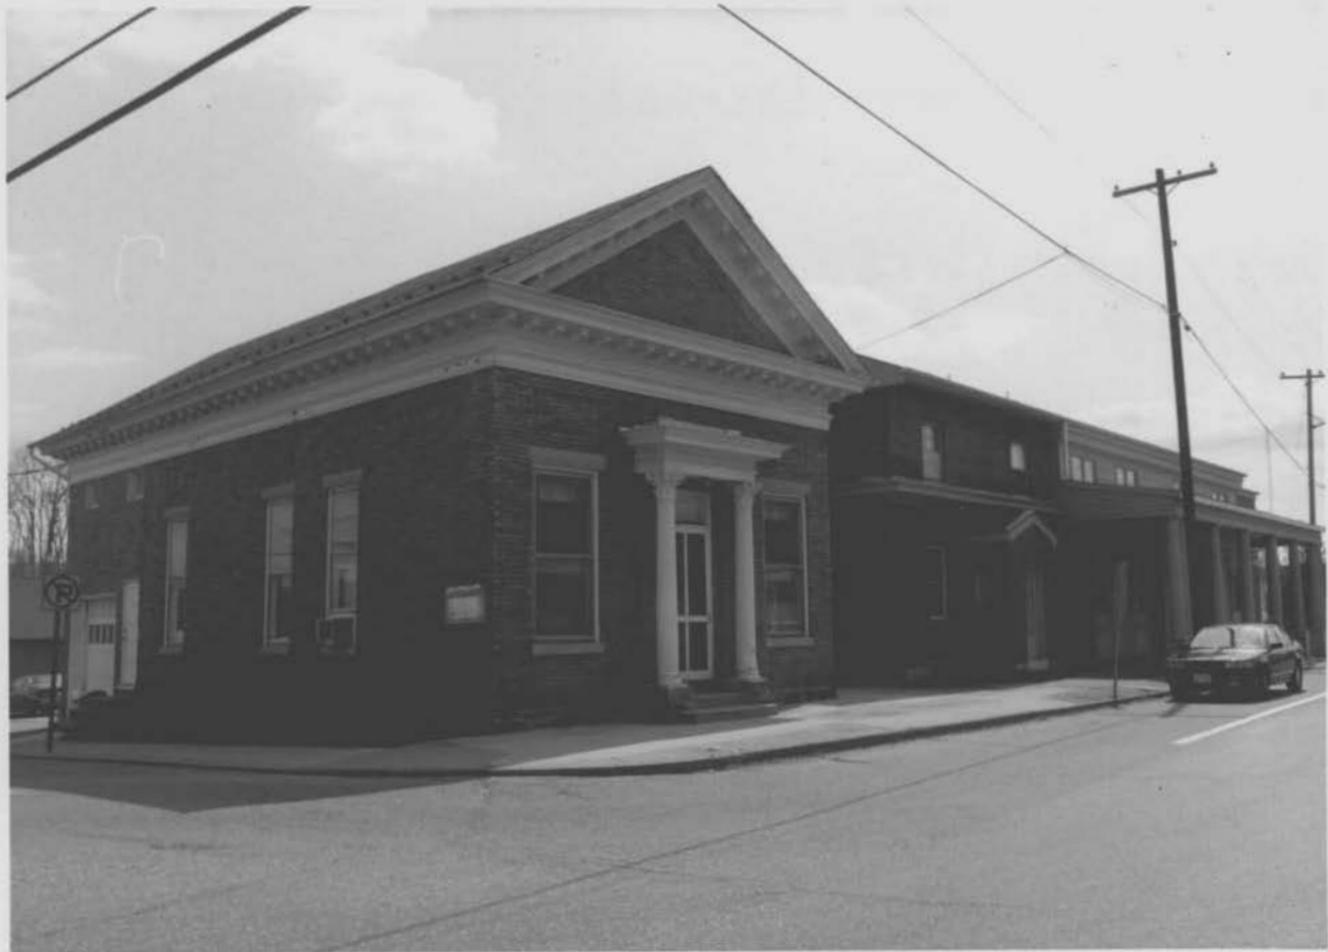
10/23

People's Supply Store, 311 Main St.: This two-story brick building was erected in 1919 to replace a frame store building burned in the 1919 fire which destroyed several buildings on the southeast corner of Ellerton Road and Main Street. It has an overhanging canopy supported on fluted Doric columns which extends over the sidewalk on the west elevation. The former storefront is boarded over. Flanking the center section are two-story sections with a projecting vestibule on the north section and a plain doorway on the south section. The roof is flat and the windows are replacements. The building is now used as an apartment house. Originally it contained a general store, the Farmers Mutual Exchange, which had operated in the frame building destroyed in the 1919 fire. In 1924, the store was renamed People's Supply Store. The trolley substation also was in the same building. Behind the building was a large grain elevator and warehouse, the site now being occupied by the modern shopping center and a parking lot.

Flook, Gaver, Leatherman, Summers, Grossnickle and Company Bank, 313 Main St.: This is a one-story brick Classical Revival bank currently used as the office of an electrical contractor. The building was erected in 1919 to replace the 1902 bank destroyed in the fire. It has a three-bay west elevation with a full pediment and a center doorway flanked by Composite columns. The walls are buff colored brick with rusticated stone lintels and sills. The modillion cornice

Flook, Gavel, Leatherman, Summers, Crossnickle + Co.  
Bank and People's Supply Store buildings, view  
from northwest

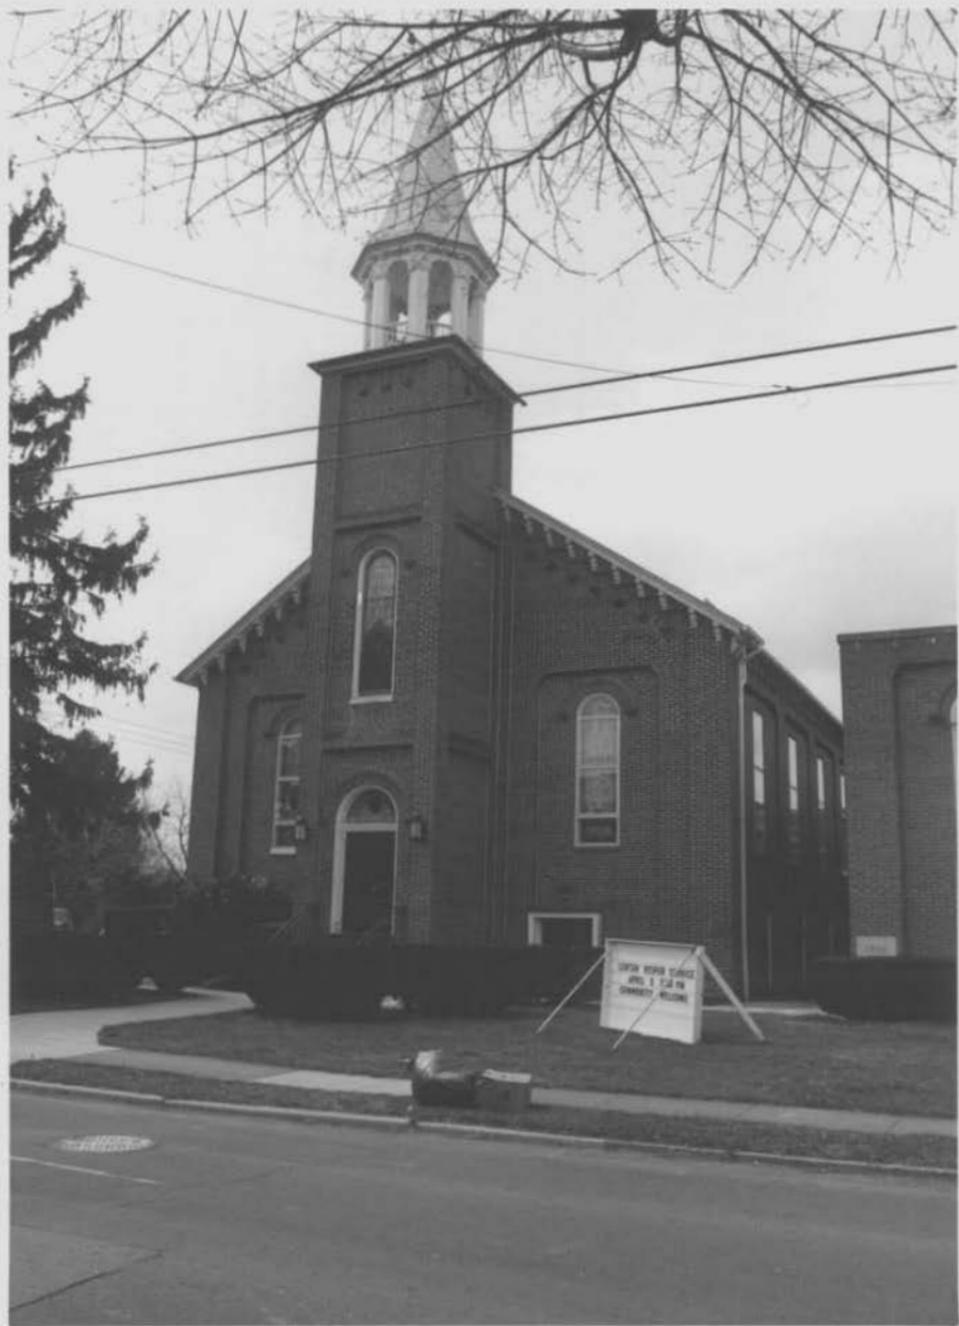
11/23

**St. Paul's Evangelical Lutheran Church:** This brick hall plan church was built in 1872 in a simple Romanesque Revival style and rebuilt in 1896 after storm damage destroyed much of the roof and the interior. It has a three-bay east elevation with a projecting bell tower containing the entrance. The windows and doorway have round arches and are recessed in panels which extend up the tower to the base of the polygonal open belfry with a bellcast steeple. The windows have early 20th century stained glass. The eaves have corbeled decoration and brackets. Adjoining the church on the north side is a 1966 education building. A large cemetery extends to the west behind the church. The St. Paul's congregation was organized in 1851, growing out of the St. John's Church at Church Hill. The first church building, on the same site as the existing building, was built in 1852 and destroyed by fire in 1872.

St. Paul's Lutheran Church, east elevation

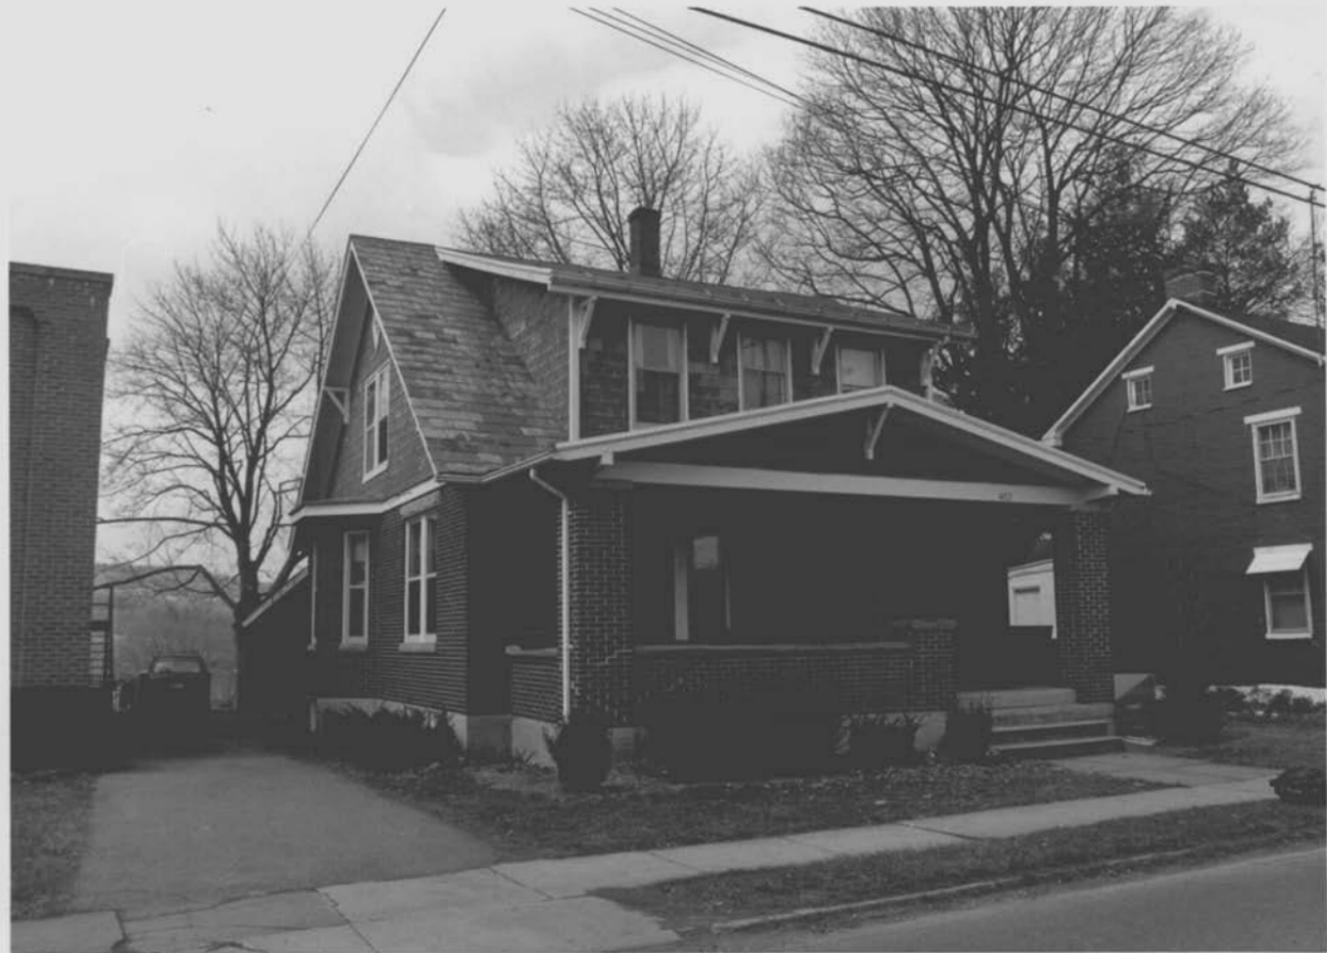
12/23

**Lutheran Parsonage, 402 Main St.:** The Parsonage was built about 1922. It is a 1-1/2 story frame bungalow with brick veneer on the first story and shingled gables on the upper level. A slate-sided shed dormer with three windows and bracketed eaves and a one-story porch with brick piers dominate the east elevation. The roof is also slate. The sash is 1/1. Paired and three-part windows are present, as well as a polygonal bay window on the south elevation.

Lutheran Parsonage, 402 Main St. southeast  
corner view

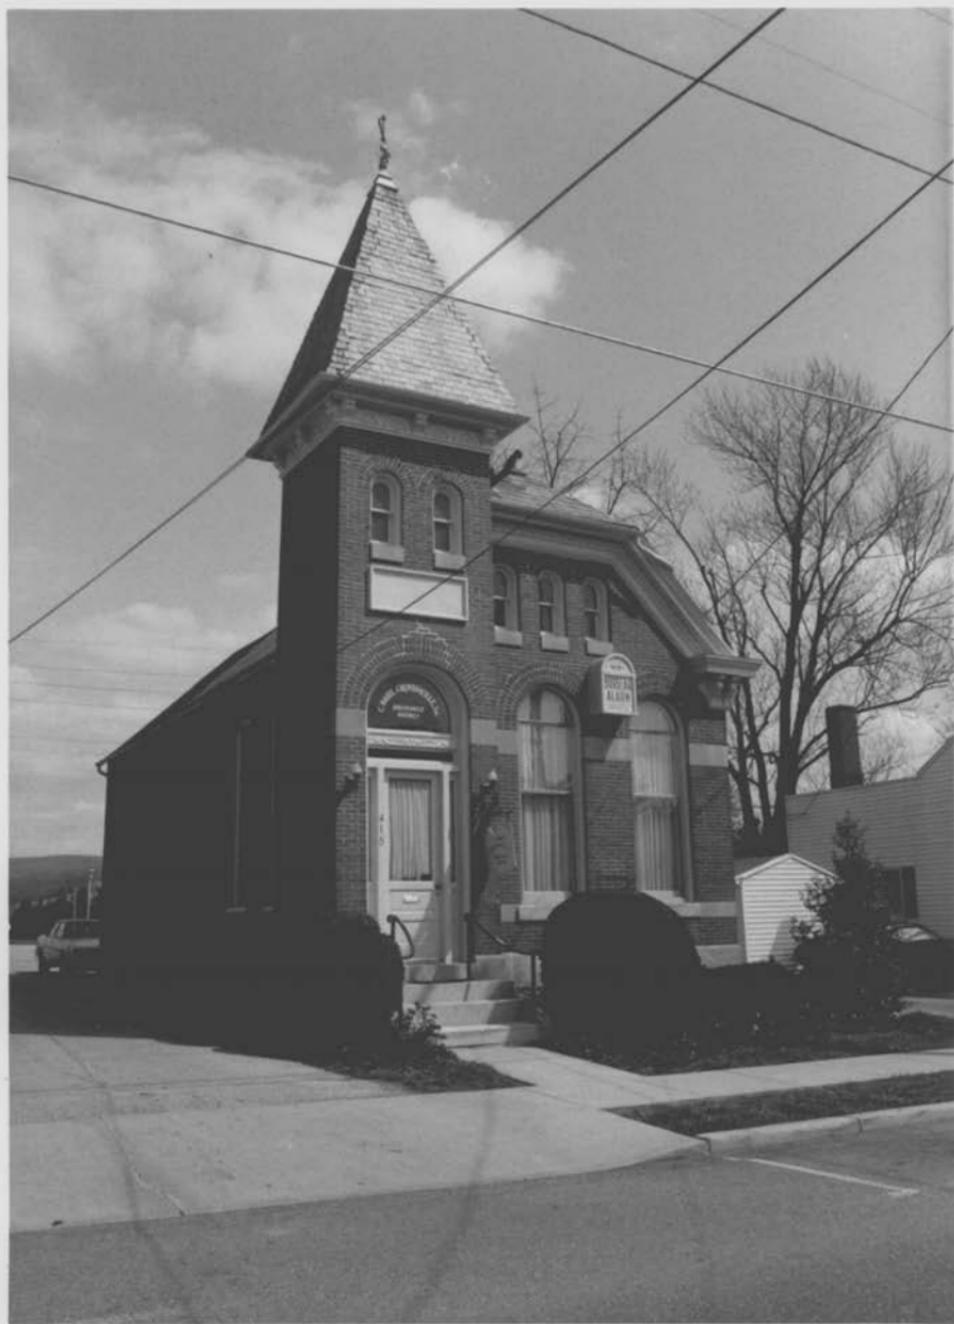
14/23

Myersville Savings Bank, 415 Main St.: The 1902 two-story bank building is in an eclectic style with elements of the Romanesque and Renaissance Revival styles. It has a generally three-part west elevation with a hipped roof tower on the northwest corner and two bays of round-arched windows on the south. Banks of smaller arched windows are located in the second story, and the brick walls are divided by stone belt courses. The roof is slate with a clipped gable on the west elevation, accentuated by a bracketed return at the southwest corner. The bank was founded in 1898 and survived the 1930's depression. The building was sold in the 1970's and the bank moved to a modern structure on Main Street at Monument Road. The 1902 building is currently an insurance office.

Myersville's Savings Bank, Main St., west elevation

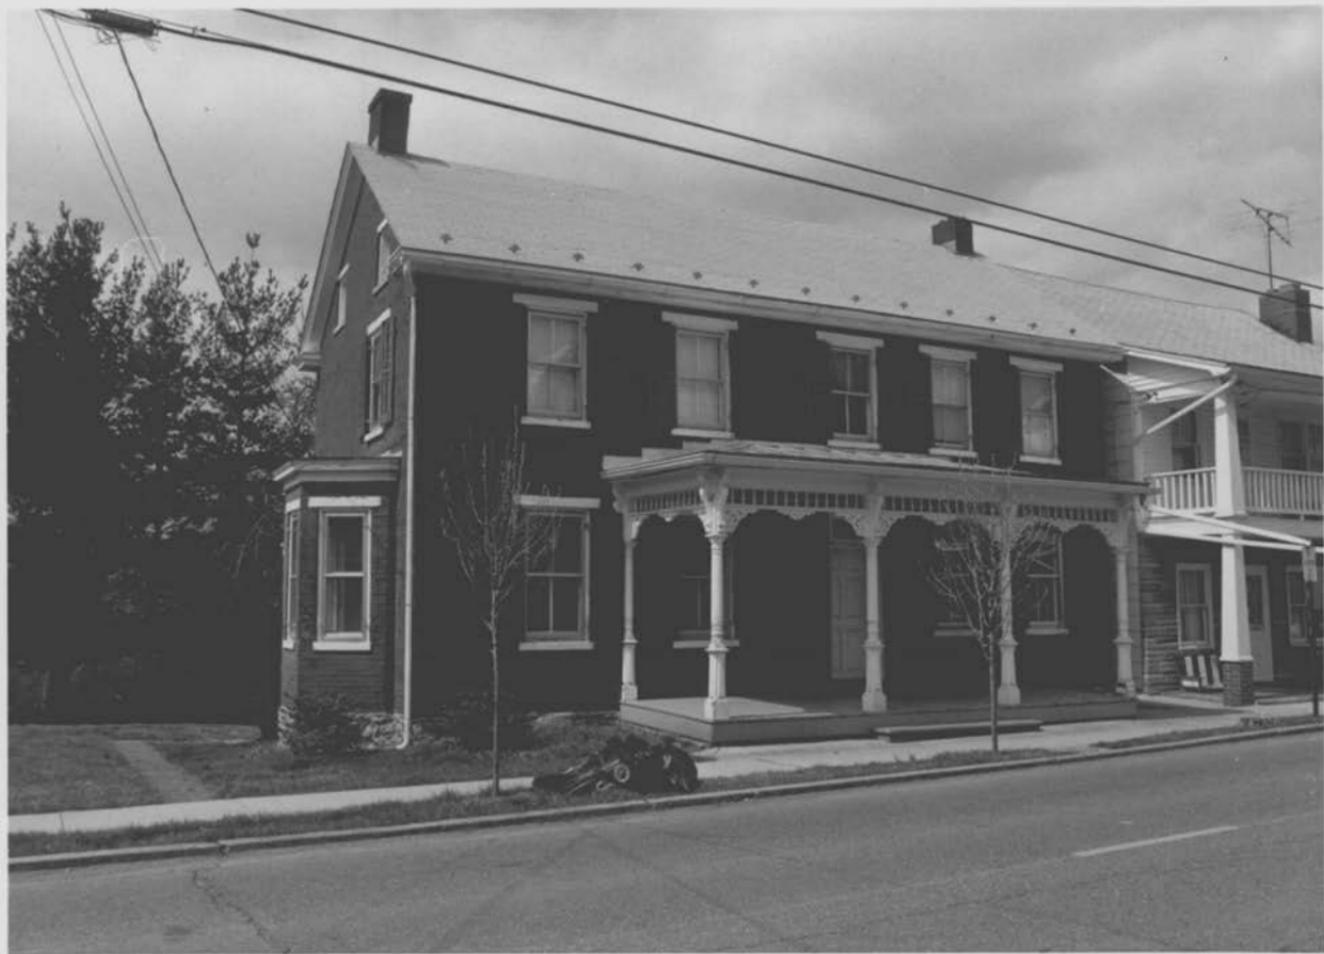
16/23

**Isaiah Moser House, 412 Main St.:** This is a two-story brick house built about 1865. It has five bays on the east elevation with a one-story bracketed porch over the center three bays. A one-story polygonal bay window projects from the south elevation. The windows are 2/2 and the shutters are louvred. The lintels and sills are plain wood. The roof is composition with interior end chimneys. The house is representative of the vernacular houses of the town prior to the arrival of the trolley line in 1898.

Isaiah West House, east elevation

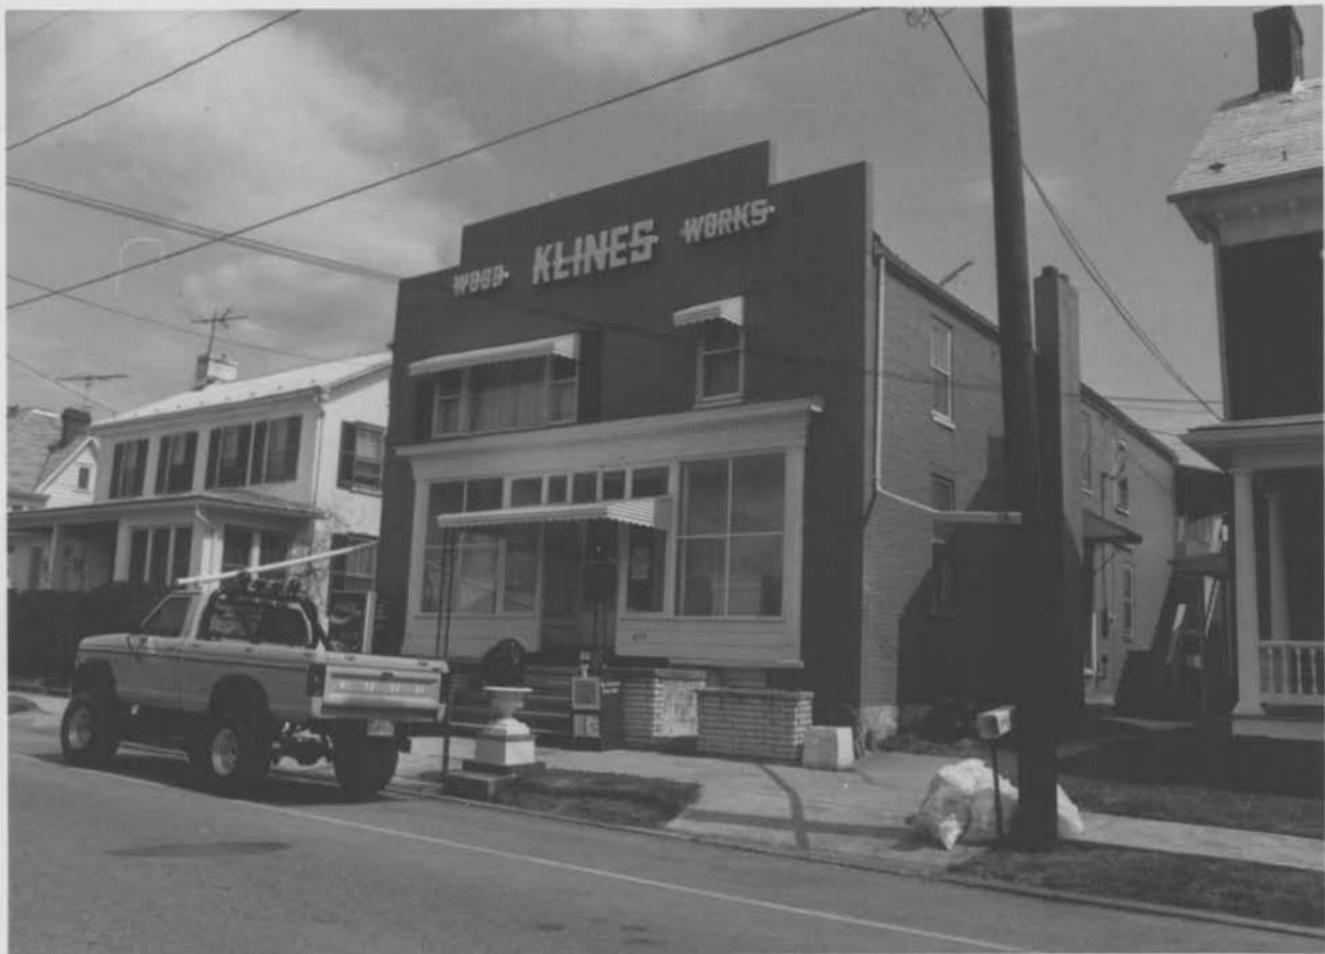
17/23

**George Bittle Store, 419 Main St.:** This is a much-altered commercial building of the last quarter of the 19th century. Moser's 1905 history shows its original form as a two-story brick building with a partial gable facade and a storefront with a recessed entrance between large, 2/2 display windows. The second story had three bays with 2/2 windows. In the early 20th century, the building's roofline and facade were altered, eliminating the irregular appearance and adding a stepped brick parapet. The storefront remains remarkably intact, with a metal awning covering the entrance and the dentil cornice and the display windows shown in the 1905 photo still in place. The second story has a three-part picture window and a single 1/1 window. The building's upper level served as a community hall in the early 20th century, as well as the meeting room of the Junior Order of United American Mechanics (J.O.U.A.M) local chapter. It is now a woodworking shop.

George Kittle - 2100, west elevation

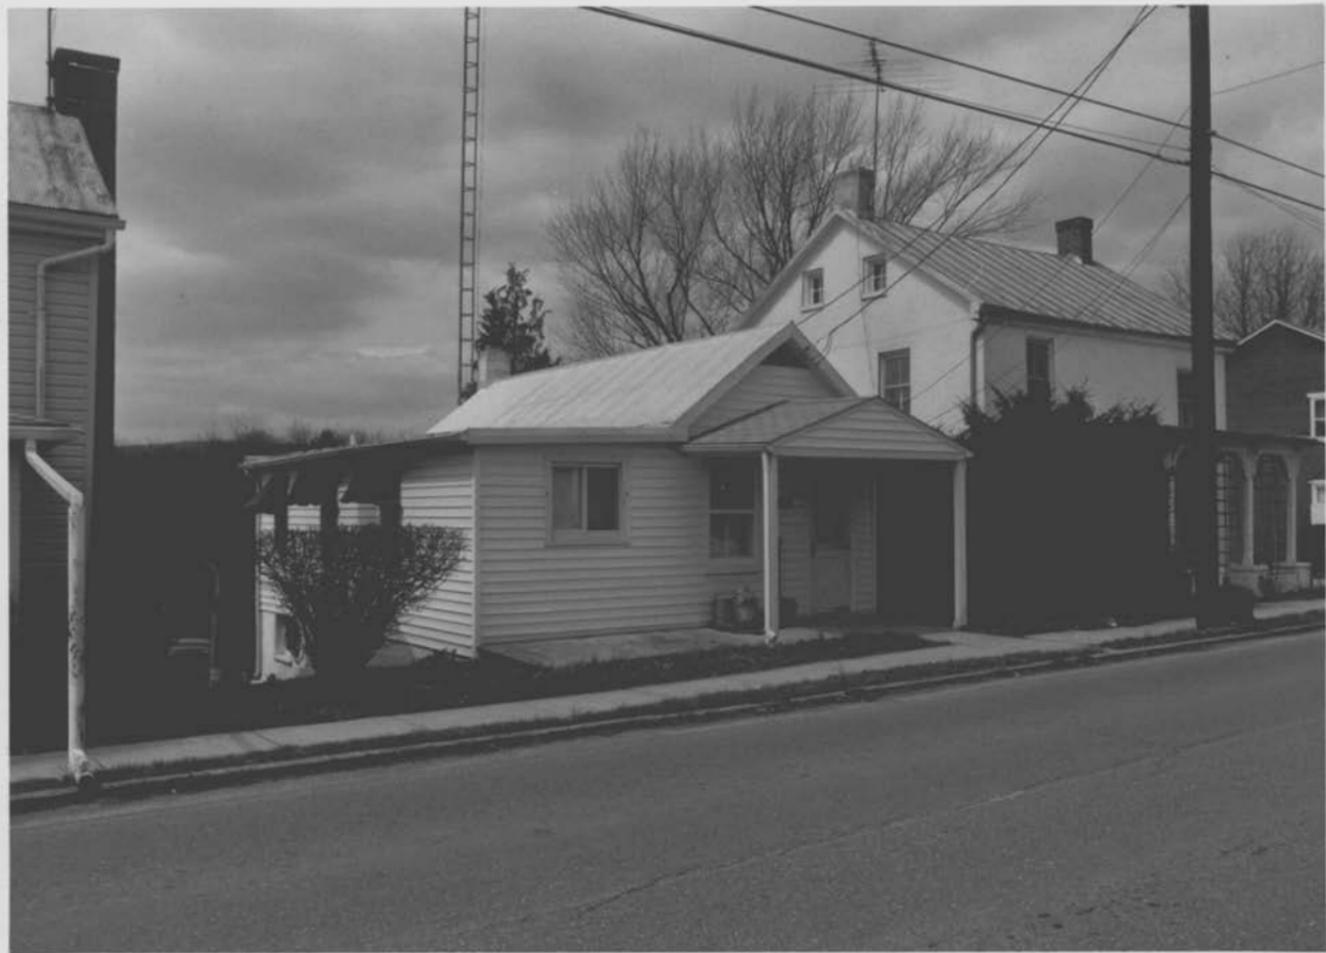
18/22

Kinnaman Harness and Shoe Shop, 418 Main St.: This one-story shop dating from the last quarter of the 19th century has been expanded on the west elevation to two levels and converted to residential use. It retains much of its original appearance on the east elevation, with a two-bay elevation under a small gabled porch roof and a single door and 2/2 window. On the south elevation, a modern shed extension joins the rear expansion. The roof is standing seam metal and the concrete block chimney is located at the west gable end. The exterior is covered with vinyl siding. This is the only example of the small shop among the commercial buildings of the period.

Kinnaman Harness Shop, 418 Main St., east  
elevation

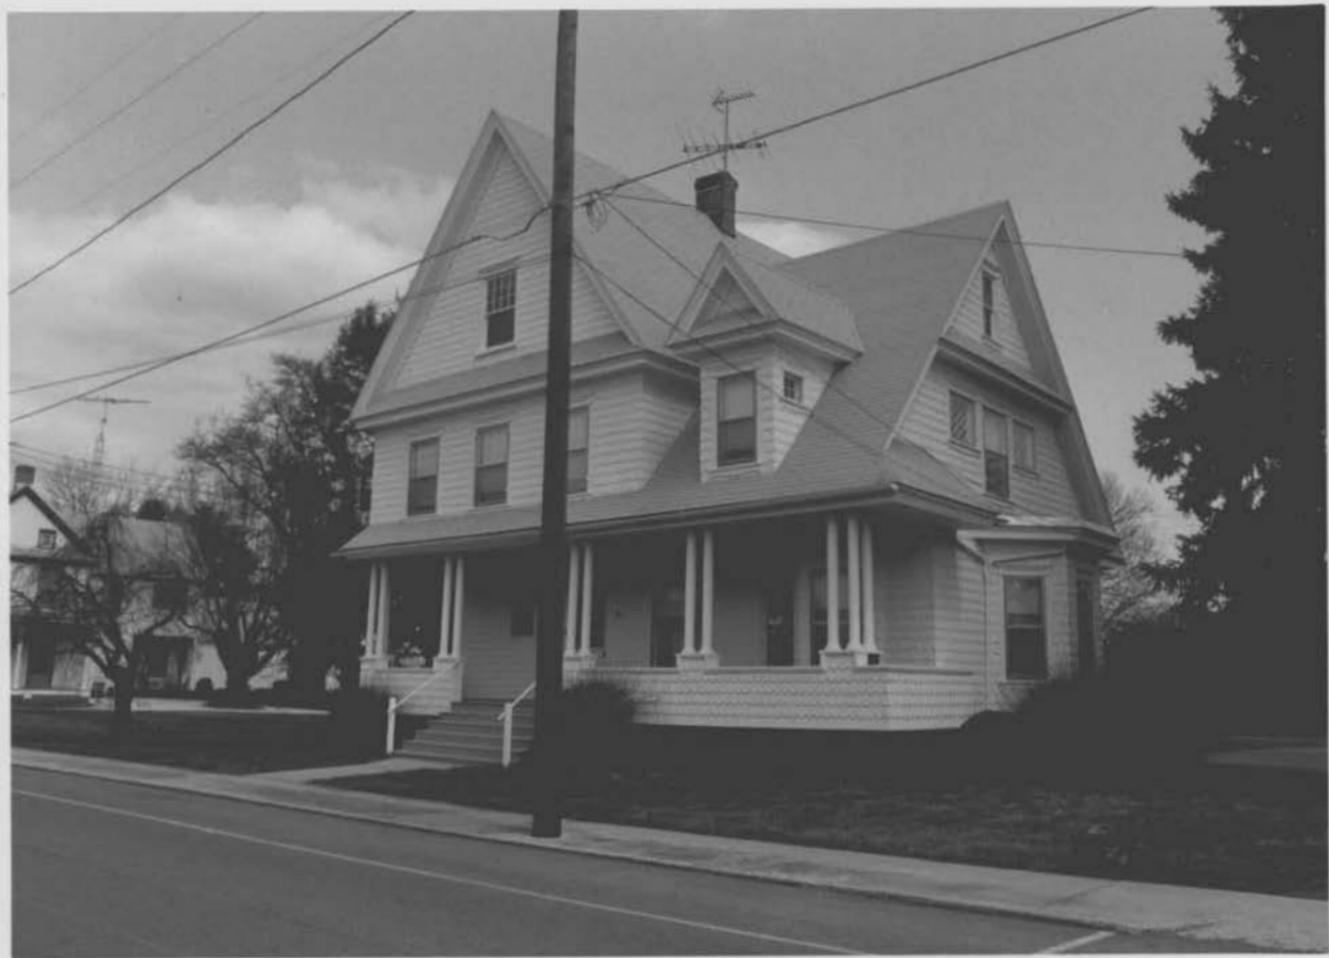
19/23

Cyrus Flook House, 507 Main St.: This 2-1/2 story frame house was built about 1900 in the Shingle Style. It has an irregular plan with a shingled exterior, multiple gables and dormers with an integral one-story porch featuring paired columns. A one-story polygonal bay extends from the south elevation. The sash is varied, with a three-part window on the south elevation with diamond pattern lights and a Queen Anne window in the gable of the west elevation. The prominent roof is composition. This house was pictured in the 1905 history and the only major changes have been the replacement of the roof material and the removal of a small balcony off the top story gable window in the west elevation. Cyrus Flook was one of the most prominent of the town's businessmen in the first quarter of the 19th century, being one of the founders of the Flook, Gaver, Leatherman, Summers, Grossnickle & Co. bank.

Cyprus Flock House, 507 Main St., west  
elevation
