## Myersville Survey District

### **Architectural Survey File**

Property/District Name: Myersville Survey District \_\_\_\_\_ Survey Number: F-4-53

# Maryland Historical Trust State Historic Sites Inventory Form

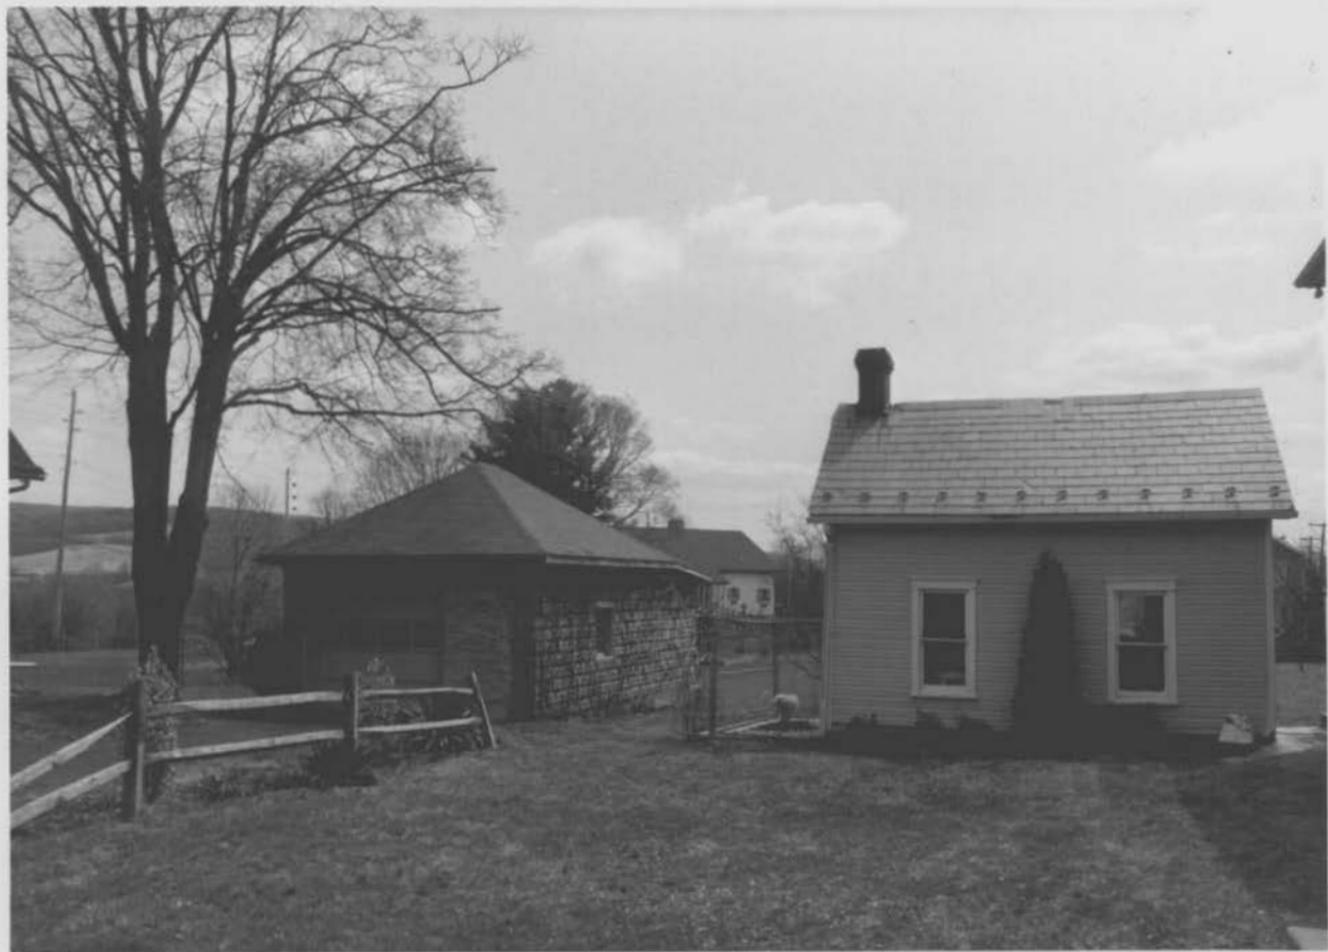
20/23

Road 20. House, wash house, & barn.  
View from west

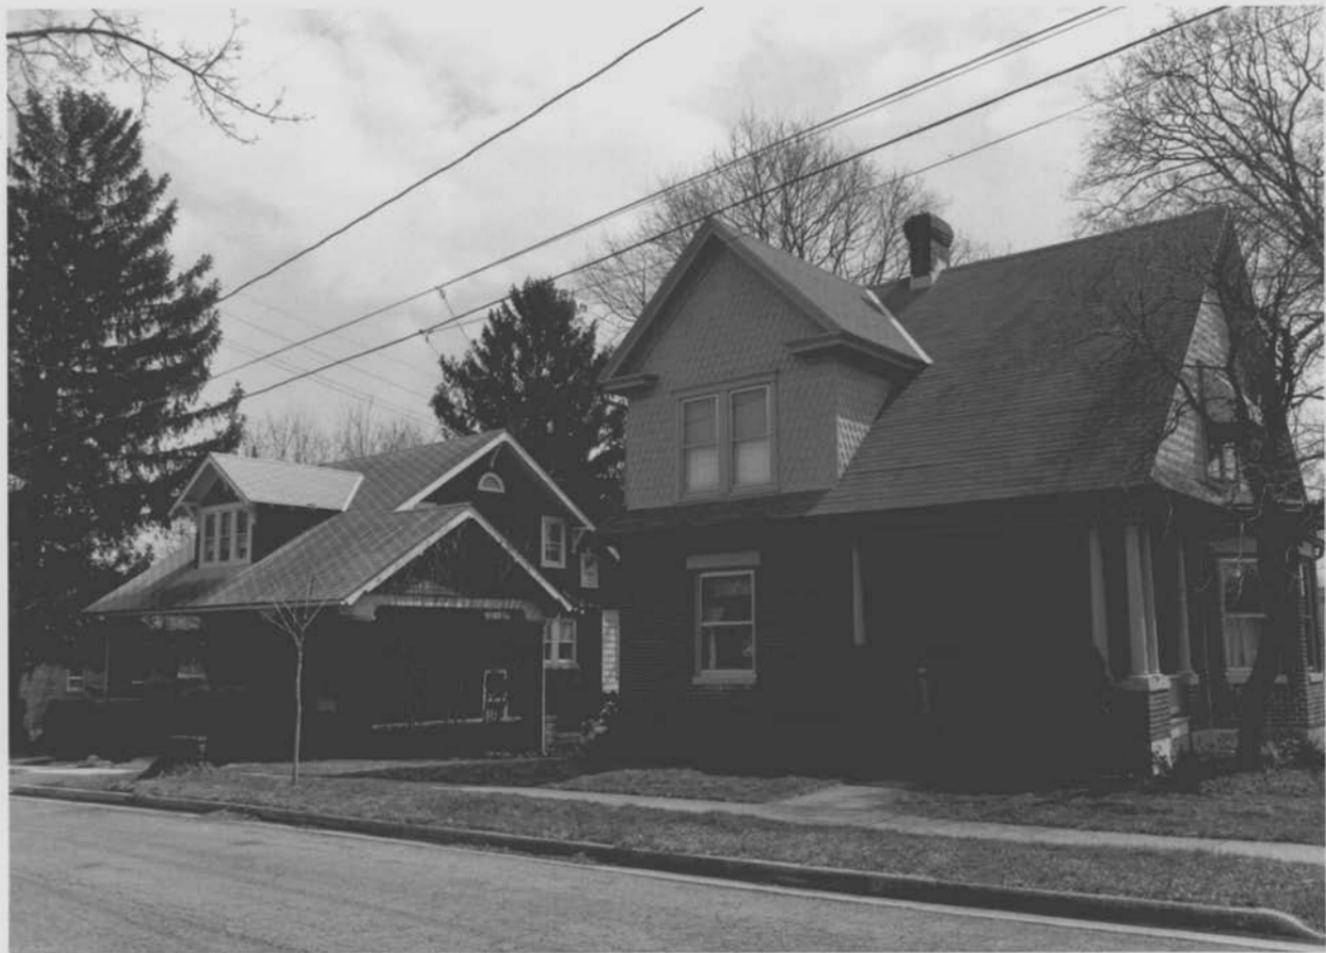
22/23

1 and 3 Harp Place: The two bungalows are each 1-1/2 stories. No. 1 has an off-center gable with shingled exterior and a partial integral porch. The lower walls are covered with brick veneer and the gables are shingled. The roof is composition. The 1/1 windows have stone lintels on the first story and a bay window extends from the west elevation. No. 1 has a rusticated concrete block garage with a hipped composition roof.

No. 3 has a gabled dormer in the north roof which extends over the integral porch with brick piers. The eaves are extended with brackets on both the main section and the dormer. The exterior is covered with shingles on the second story and the sills are rusticated stone. Both houses were built in the early 1930's and represent the moderate influx of the bungalow type in the period.

1-3. Harp Place, north elevations
